Attachment 1: Gosford Library Building Review - Draft Report - 20 December 2024 – Complete Urban 3

GOSFORD LIBRARY BUILDING REVIEW
DRAFT REPORT | 20 DECEMBER 2024

PREPARED FOR	CENTRAL COAST COUNCIL
AUTHOR	COMPLETE URBAN PTY LTD
REVISION	A
REVISION DATE	20 DECEMBER 2024
ISSUED BY	SCOTT WILLIAMS

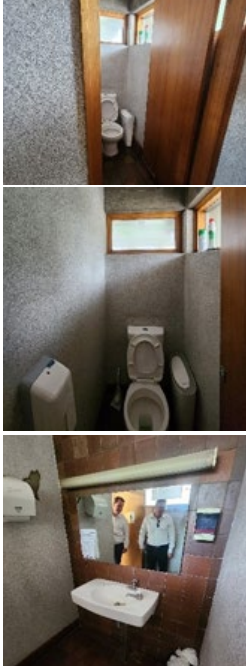
<p>Good</p>	<p>Ramped threshold unlikely to comply with current NCC and could be a tripping hazard.</p>
<p>Toilets.</p>

<p>Good condition.</p>	<p>Compliance with current NCC unlikely. There is no compliant PWD. No designated ambulant cubicles. Depending on thickness of wall finishes achieving a compliant width may not be possible without considerable demolition.</p>

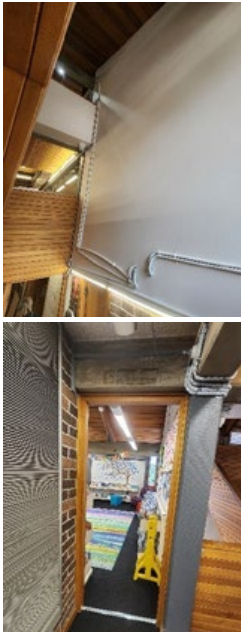
<p>Poor</p>	<p>Location of switchboard in the middle of the building on the lower level. Clearance spaces around switch room are unlikely to comply with current standards. Capacity of switchboard to accommodate current electrical needs is unknown.</p>
<p>Electrical and communication services</p>

<p>Poor</p>	<p>Considerable evidence of retrofitted electrical, lighting and communications cabling throughout the building. Given the solid concrete construction much of the retrofitted cabling is not concealed.</p>

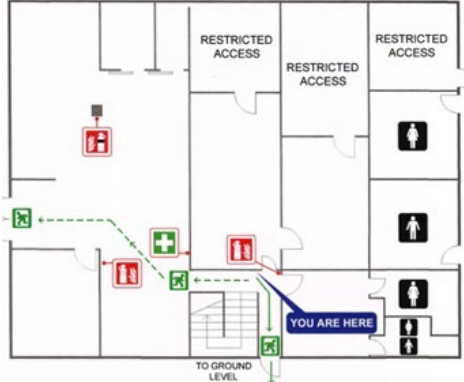
Fire Hose Reels.

Good	<p>No fire hose reels were identified on site. A fire hose reel would be expected within 4m of the front exit. Given size of building a further fire hose reel may be required at the rear door.</p> <p>The building is served by fire extinguishers across all 3 levels.</p>

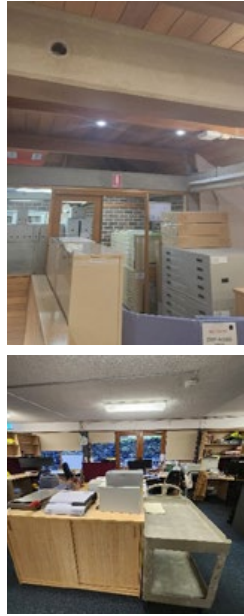
GOSFORD LIBRARY BUILDING REVIEW			
ITEM	PHOTO	COMMENTARY ON CONDITION	IDENTIFICATION OF CONCERN
Lighting levels.

Average	It appears that original lighting has been replaced. However, there are still some areas where lighting levels appear too low. Eg on lower floor and in centre of mezzanine floor.
Mechanical Services.		Average	The existing mechanical system is in various locations around the building, including under the ground floor space at the front of the building. Maintenance access is confined. Additionally given the age of the units, the existing refrigerant should be checked for compliance with current legislation

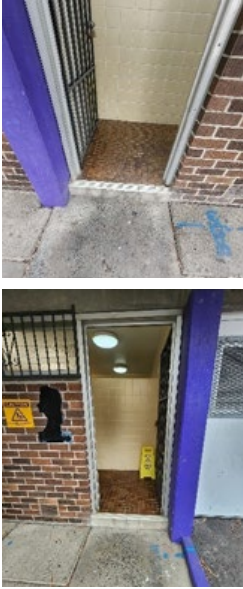
ITEM	PHOTO	COMMENTARY ON CONDITION	IDENTIFICATION OF CONCERN
<p>Entry to public toilets.</p>

<p>Access to the public toilets on the western side of building are accessed via a small step.</p>	<p>Non-compliant access at doorways to external public toilets – steps and width of opening (some doorways maybe undersized)</p>
<p>Public toilets. Mosaic floor tiles, terrazzo toilet partitions, wall tiling</p>
