1.3 Existing Gosford Library Building Review Panel - Progress Report One (1)

GOSFORD LIBRARY BUILDING REVIEW
DRAFT REPORT | 20 DECEMBER 2024

GOSFORD LIBRARY BUILDING REVIEW

PREPARED FOR	CENTRAL COAST COUNCIL
AUTHOR	COMPLETE URBAN PTY LTD
REVISION	A
REVISION DATE	20 DECEMBER 2024
ISSUED BY	SCOTT WILLIAMS

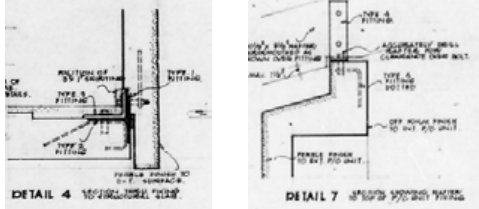
ITEM	PHOTO	COMMENTARY ON CONDITION	IDENTIFICATION OF CONCERN
<p>External concrete walls. The middle level perimeter walls are precast concrete structures. Whilst these walls are generally suspended above the ground, they appear to be supporting the roof beams. It is also likely that they contribute to the lateral stability of the structure.</p>

<p>Condition appears reasonable with little or no evidence of spalling.</p>	<p>It is not known how the panels are affixed to the building. Given the age of the building, earthquake and fire rating compliance cannot be confirmed without further structural investigation including undertaking intrusive investigations</p>

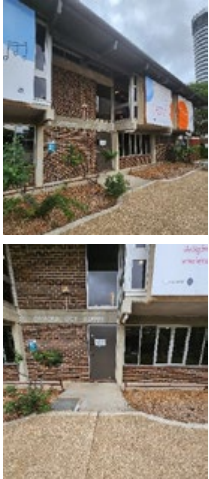
<p>DETAIL 4: SECTION OF TYPE 3 PILING TO TYPE 1 BEAM. DETAIL 7: SECTION OF TYPE 4 PILING TO TYPE 1 BEAM.</p>
<p>Face Brickwork. External brickwork appears to be non-loadbearing.</p>

<p>External brickwork appears in reasonable condition.</p>

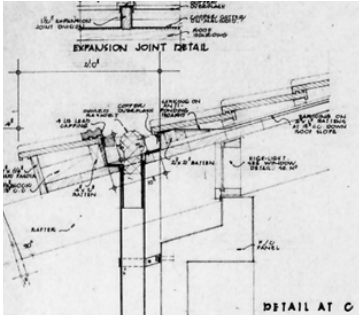
<p>DETAIL AT C</p>

ITEM	PHOTO	COMMENTARY ON CONDITION	IDENTIFICATION OF CONCERN
<p>Roof. Corrugated Colorbond roof sheet and ½ round Colorbond gutters.</p>

<p>Roof appears in reasonable condition. Roof and eaves gutters were replaced in 2017. Original roof was tiled, and detail incorporated an edge box gutter detail with straight downpipes. Downpipes appear to be original.</p> <p>Original timber roof beams appear in good condition and current extent of roof cover provides more protection to ends of beams.</p>	<p>Gutter and downpipe sizes not checked but unlikely to comply with current Australian Standards.</p>

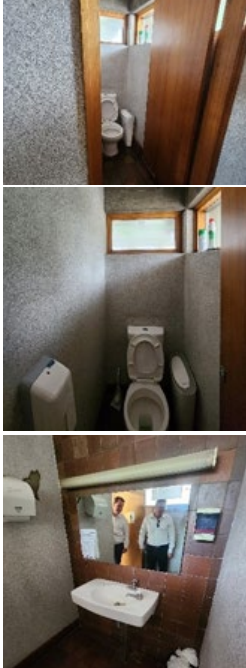
<p>Good</p>	<p>Ramped threshold unlikely to comply with current NCC and could be a tripping hazard.</p>
<p>Toilets.</p>

<p>Good condition.</p>	<p>Compliance with current NCC unlikely. There is no compliant PWD. No designated ambulant cubicles. Depending on thickness of wall finishes achieving a compliant width may not be possible without considerable demolition.</p>

\$40,000 - \$50,000
5. upgrade public toilets and add PWD.	Reconfigure existing public toilets to provide compliant circulation spaces, greater amenity, address CPTED issues and add PWD. (portion of existing substation space to be used as required for PWD)

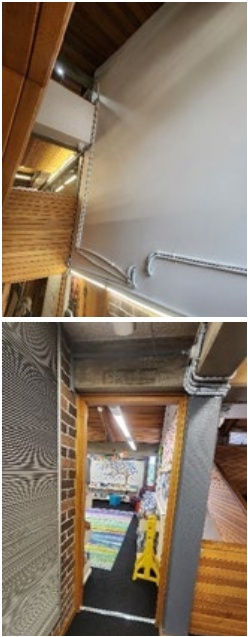
<p>Poor</p>	<p>Location of switchboard in the middle of the building on the lower level. Clearance spaces around switch room are unlikely to comply with current standards. Capacity of switchboard to accommodate current electrical needs is unknown.</p>
<p>Electrical and communication services</p>

<p>Poor</p>	<p>Considerable evidence of retrofitted electrical, lighting and communications cabling throughout the building. Given the solid concrete construction much of the retrofitted cabling is not concealed.</p>

17. Power and data	Upgrade power and data across all 3 levels to eliminate exposed cabling and conduits.

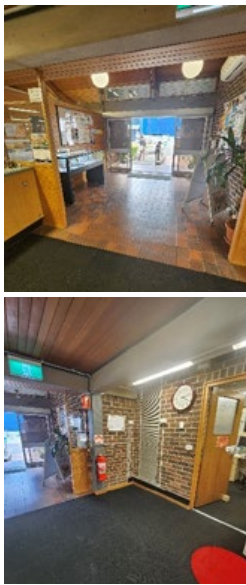
<p>Fire Hose Reels.</p>

<p>Good</p>	<p>No fire hose reels were identified on site. A fire hose reel would be expected within 4m of the front exit. Given size of building a further fire hose reel may be required at the rear door.</p> <p>The building is served by fire extinguishers across all 3 levels.</p>

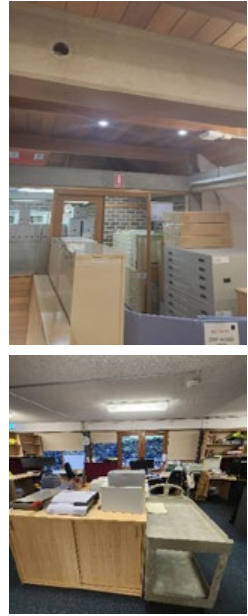
GOSFORD LIBRARY BUILDING REVIEW			
ITEM	PHOTO	COMMENTARY ON CONDITION	IDENTIFICATION OF CONCERN
Lighting levels.

Average	It appears that original lighting has been replaced. However, there are still some areas where lighting levels appear too low. Eg on lower floor and in centre of mezzanine floor.
Mechanical Services.		Average	The existing mechanical system is in various locations around the building, including under the ground floor space at the front of the building. Maintenance access is confined. Additionally given the age of the units, the existing refrigerant should be checked for compliance with current legislation

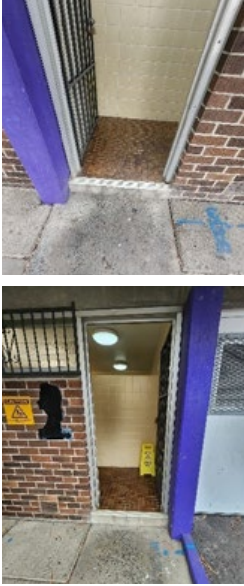
ITEM	PHOTO	COMMENTARY ON CONDITION	IDENTIFICATION OF CONCERN
<p>Entry to public toilets.</p>

<p>Access to the public toilets on the western side of building are accessed via a small step.</p>	<p>Non-compliant access at doorways to external public toilets – steps and width of opening (some doorways maybe undersized)</p>
<p>Public toilets. Mosaic floor tiles, terrazzo toilet partitions, wall tiling</p>

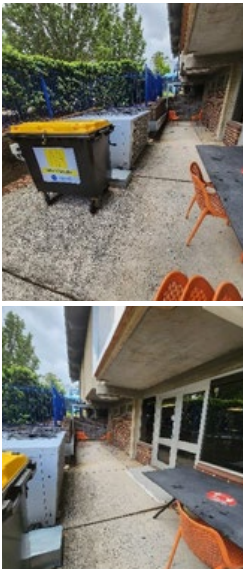
<p>Average condition</p>	<p>Potential entrapment space.</p>
<p>Eastern Courtyard</p>

<p>Average</p>	<p>Eastern courtyard provide egress from the lower floor. The courtyard is hidden behind landscaping and provides a haven for antisocial behaviour.</p>

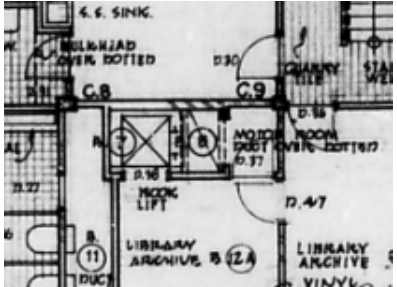
Poor	<p>Multiple confined or enclosed spaces including: Former book hoist.</p>

\$5,000 - \$10,000
14. Book hoist	Completely remove book hoist across basement, ground and mezzanine and make good.
