ENVIRONMENT AND PLANNING COMMITTEE

**ATTACHMENTS PROVIDED UNDER
SEPARATE COVER**

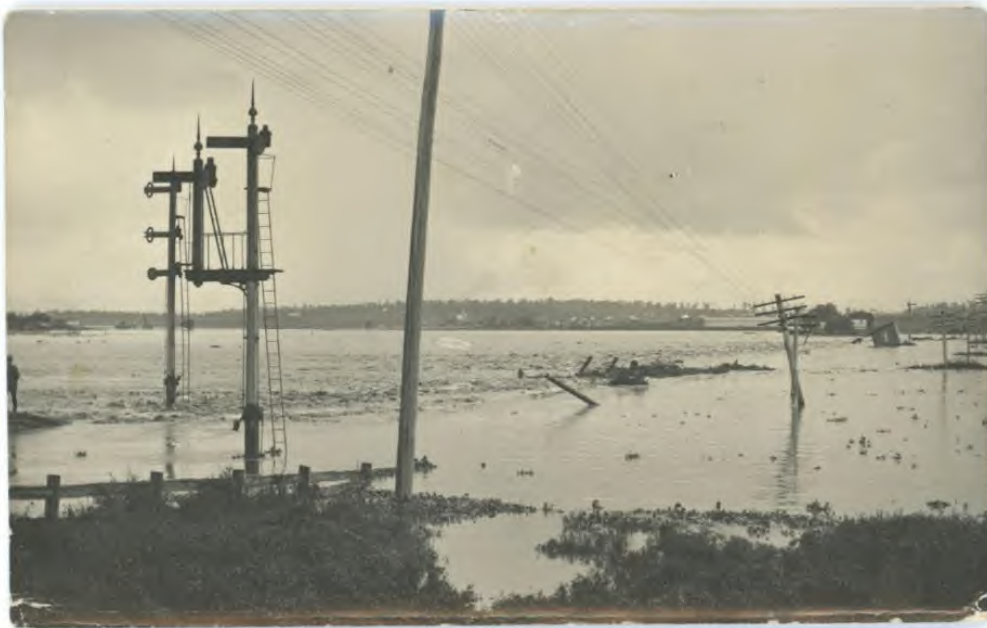
Figure 1.2 Flooding c. 1909 looking south from Wyong through to Tuggerah over the road and train lines. Courtesy of Central Coast Council

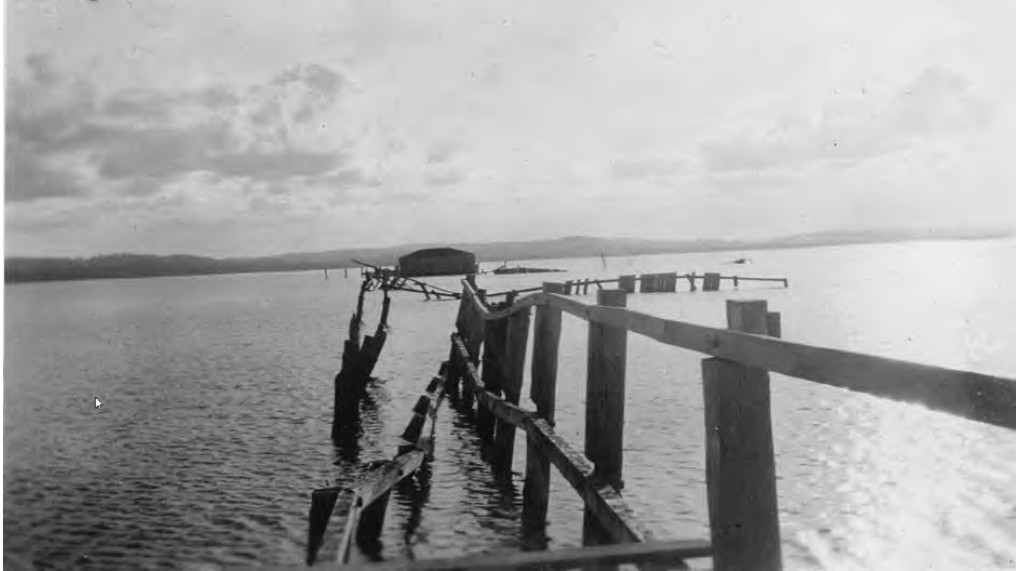
Figure 1.3 Damages to the original Long Jetty (built 1914 by William Henry Price) following flooding in Easter 1927. Courtesy of Central Coast Council

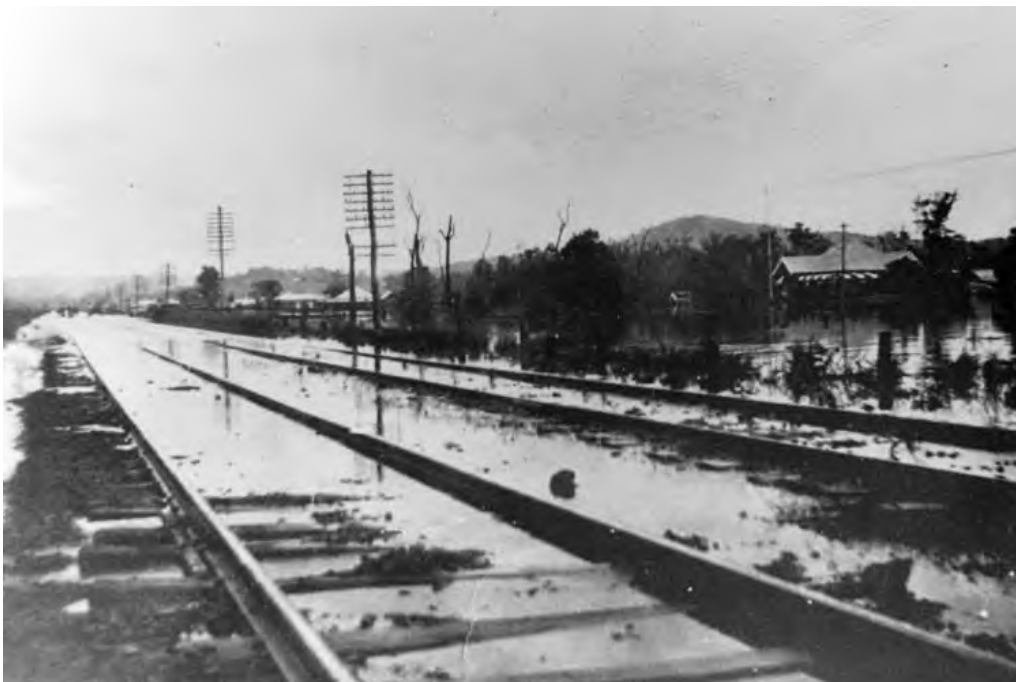
Figure 1.4 Northern railway line just north of Tuggerah Station covered by flood waters, Wyong 1927. Courtesy of Central Coast Council
