1.3 Existing Gosford Library Building Review Panel - Progress Report One (1)

GOSFORD LIBRARY BUILDING REVIEW
DRAFT REPORT | 20 DECEMBER 2024

GOSFORD LIBRARY BUILDING REVIEW

PREPARED FOR	CENTRAL COAST COUNCIL
AUTHOR	COMPLETE URBAN PTY LTD
REVISION	A
REVISION DATE	20 DECEMBER 2024
ISSUED BY	SCOTT WILLIAMS

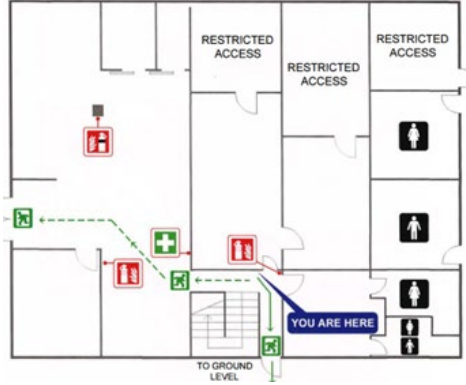
<p>Good</p>	<p>No fire hose reels were identified on site. A fire hose reel would be expected within 4m of the front exit. Given size of building a further fire hose reel may be required at the rear door.</p> <p>The building is served by fire extinguishers across all 3 levels.</p>
